GUNITE AND CONCRETE
ENCASEMENT
TO INCREASE THE STRENGTH OF
STRUCTURAL STEEL

BULLETIN No. 37

*Professors of Civil Engineering
The Ohio State University*

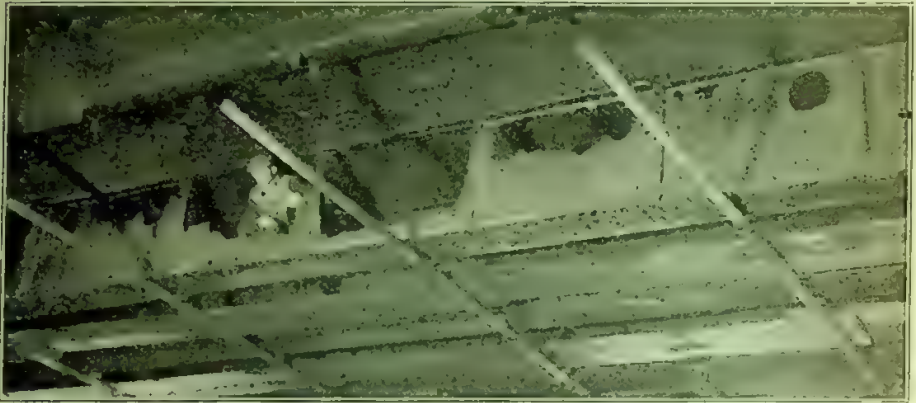
FIGURE 12

Shortly after the tests at the Engineering Experiment Station had demonstrated the possibility of strengthening corroded steel members, an opportunity for a practical test was presented at the North High Street Viaduct in Columbus, Ohio, where the badly corroded condition of the steel work made necessary either replacement or repair of the structure. As Figure 12 shows, holes in the

webs of some of the girders were large enough for a man to crawl through. It was suggested that encasement of the old girders in reinforced gunite might restore the carrying capacity of the viaduct, add a considerable period of years to its service, and at the same time save money and the inconvenience of detouring traffic during construction.
